GLASS BEACH REMEDIAL ACTION PLAN ADDENDUM, REMEDIAL ACTION PLAN & CORRESPONDENCE

NOTICE OF AVAILABILITY AND
NOTICE OF INTENT TO ADOPT A NEGATIVE DECLARATION

PROJECT TITLE: Glass Beach Site Remediation; Coastal Development Permit #7-02

ENVIRONMENTAL CHECKLIST FORM & DRAFT MITIGATED NEGATIVE DECLARATION

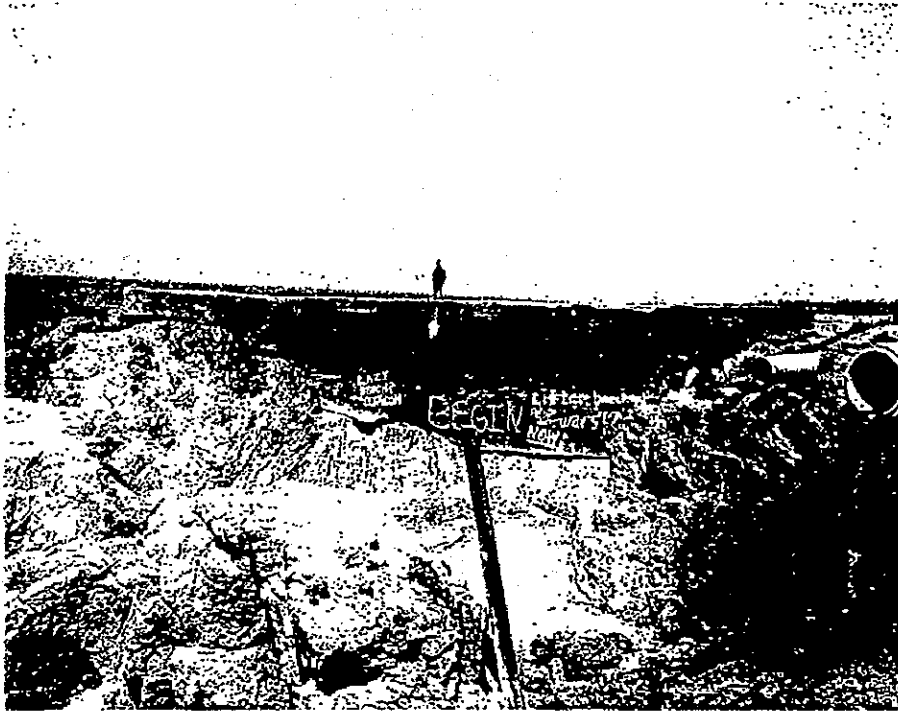
Figure 2. Photograph of the south retaining wall. City storm drain outfall pipes are visible to the right (east) of the retaining wall. Photograph taken looking north.

Two existing retaining walls on the site will also be removed, in preparation for transfer of the property to State Parks (See Attachment 3 and Figures 1 and 2). State Parks has indicated that the walls pose potential liability and maintenance issues and that they must be removed prior to acquisition of the property for public use. Some scattered debris will also be removed directly from the beaches around the proposed excavation areas and retaining walls to alleviate public hazards and to reduce potential liability issues. No work will occur on beach areas below the mean high tide line. All of the proposed excavation, refuse removal, and retaining wall removal areas are located within the City of Fort Bragg's jurisdiction for coastal development permits.

The Geotechnical Study evaluated potential issues related to the stability of two existing City storm drain outfall pipes which are located immediately east of the south retaining wall. The study determined that removal of the retaining wall would not undermine or otherwise adversely affect the City's storm drain outfalls. The rocks exposed by the wall removal should erode at the "natural" average rate of two to three inches per year. Storm waves should not be adversely deflected by the wall removal toward the outfall. Some of the debris in the splash area below the pipes is cemented by rust. If this debris is removed, some of the natural rock may be displaced, possibly increasing the erosion rate, and in time, undermining the pipe outlets.

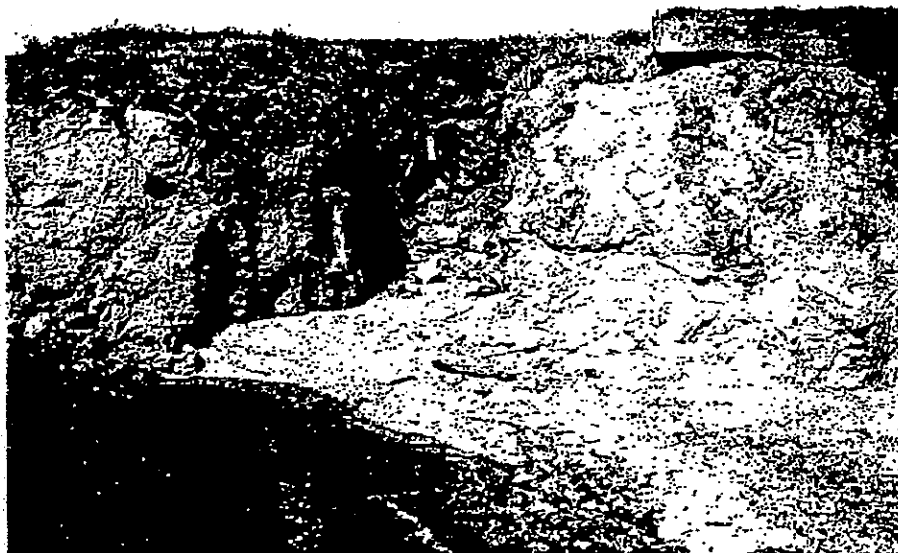
Figure 3. Exposed debris to be removed located in a small gulley to the west of the south retaining wall (the wall is visible in the upper right of the photograph). Photograph taken looking north.

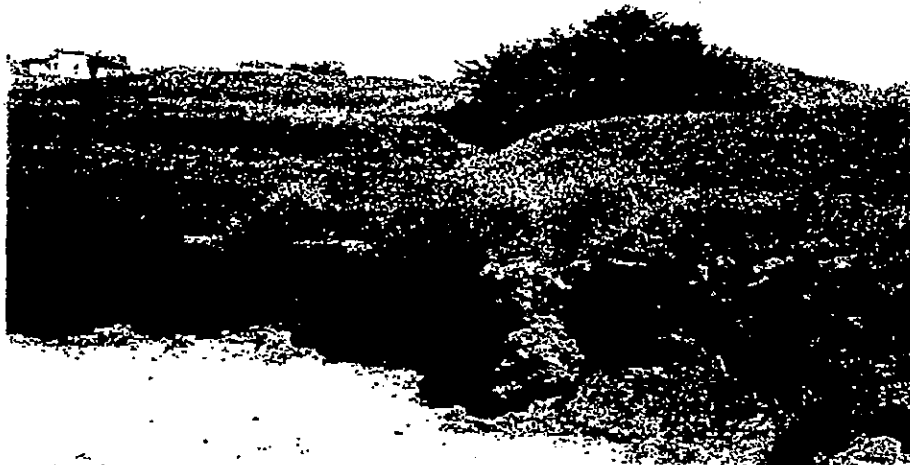
Figure 6. Photograph of northernmost area to be remediated (just south of the seasonal creek). A majority of the area visible up to the tree in the center/right would be subject to excavation. Photograph taken looking northeast.

A portion of the northernmost debris area which is identified for remediation may encroach into an existing copse of willows which forms a riparian/wetland area immediately south of the unnamed seasonal creek. The Botanical Study states that the long-term benefit of removing the hazardous materials and exotic/invasive plants from the site will far outweigh the short term impacts to the overall plant community and riparian/wetland areas.

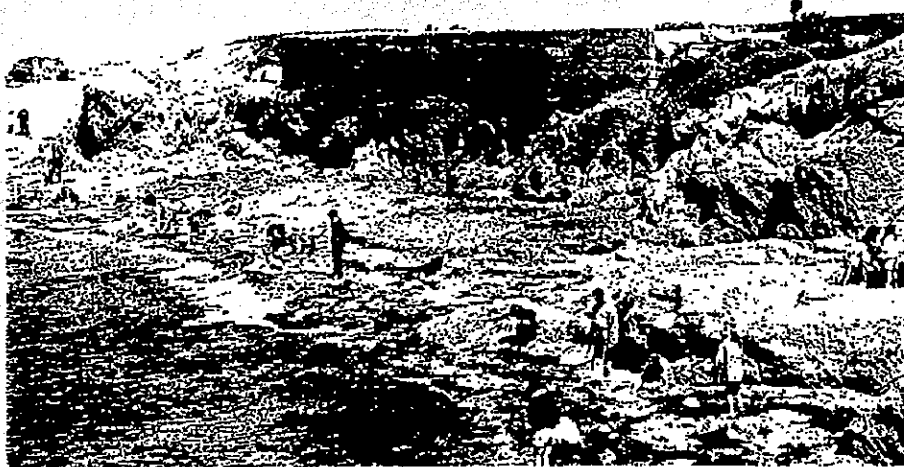
Figure 1. Photograph of the north retaining wall. Photograph taken looking northeast

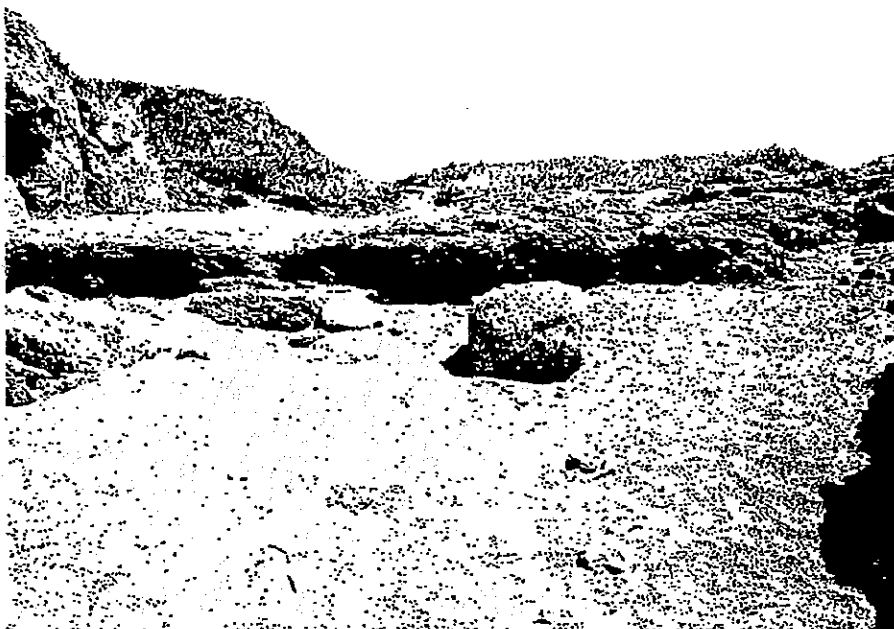
Figure 4. Photograph of area to be remediated in gulley immediately south of the north retaining wall. Photograph taken looking southeast.

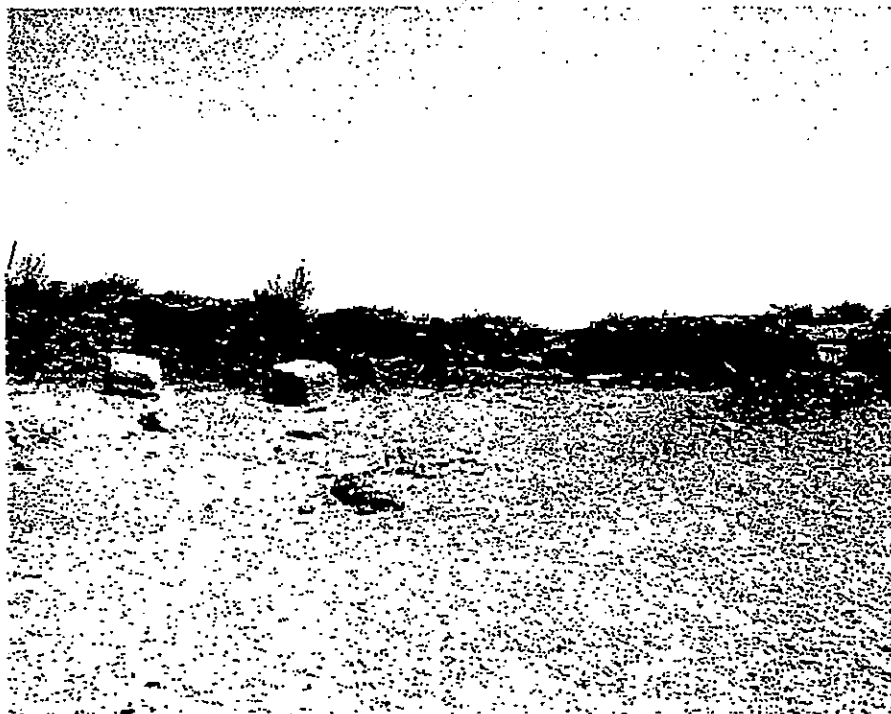
Figure 5. Photograph of exposed and embedded rubbish located just north of the north retaining wall. Photograph taken looking east.
